SHADOW RIDGE APARTMENTS
8500 GRANVILLE PARKWAY

STAFF REPORT

Appeal of Chief Building Officials Notice of Violation
Sections 304.4, 304.10, 304.12, 603.1 and 603.3 of the Property Maintenance Code
Shadow Ridge Apts.-8500 Granville Parkway

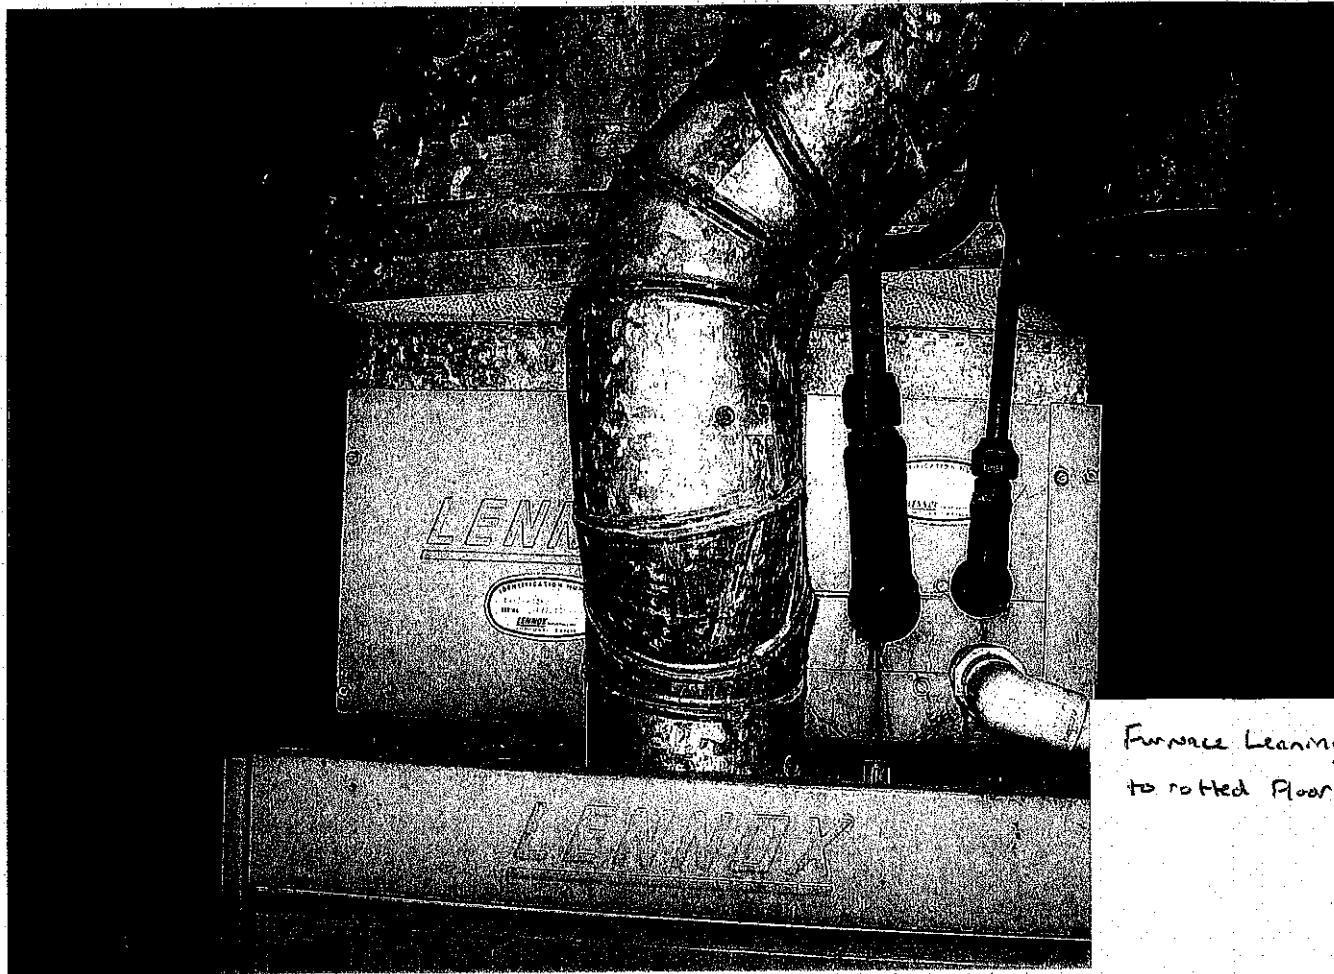
Furnace Leaning due
to rotted floor.

The rotted structural material supporting the furnaces shall be corrected. There are several crooked and leaning furnaces.

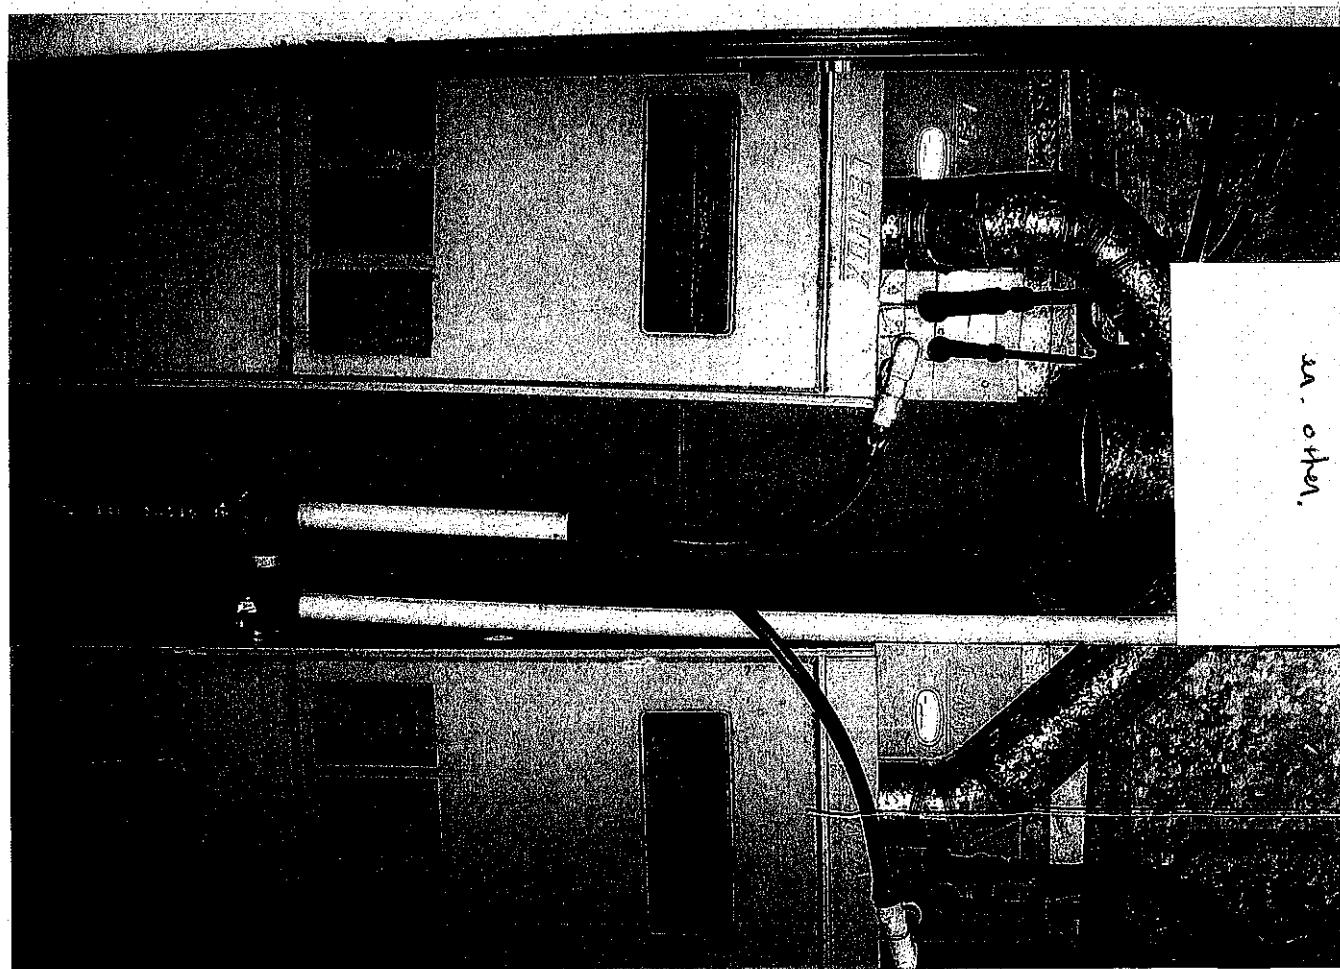
Furnace Leaning
Towards
ea. other.

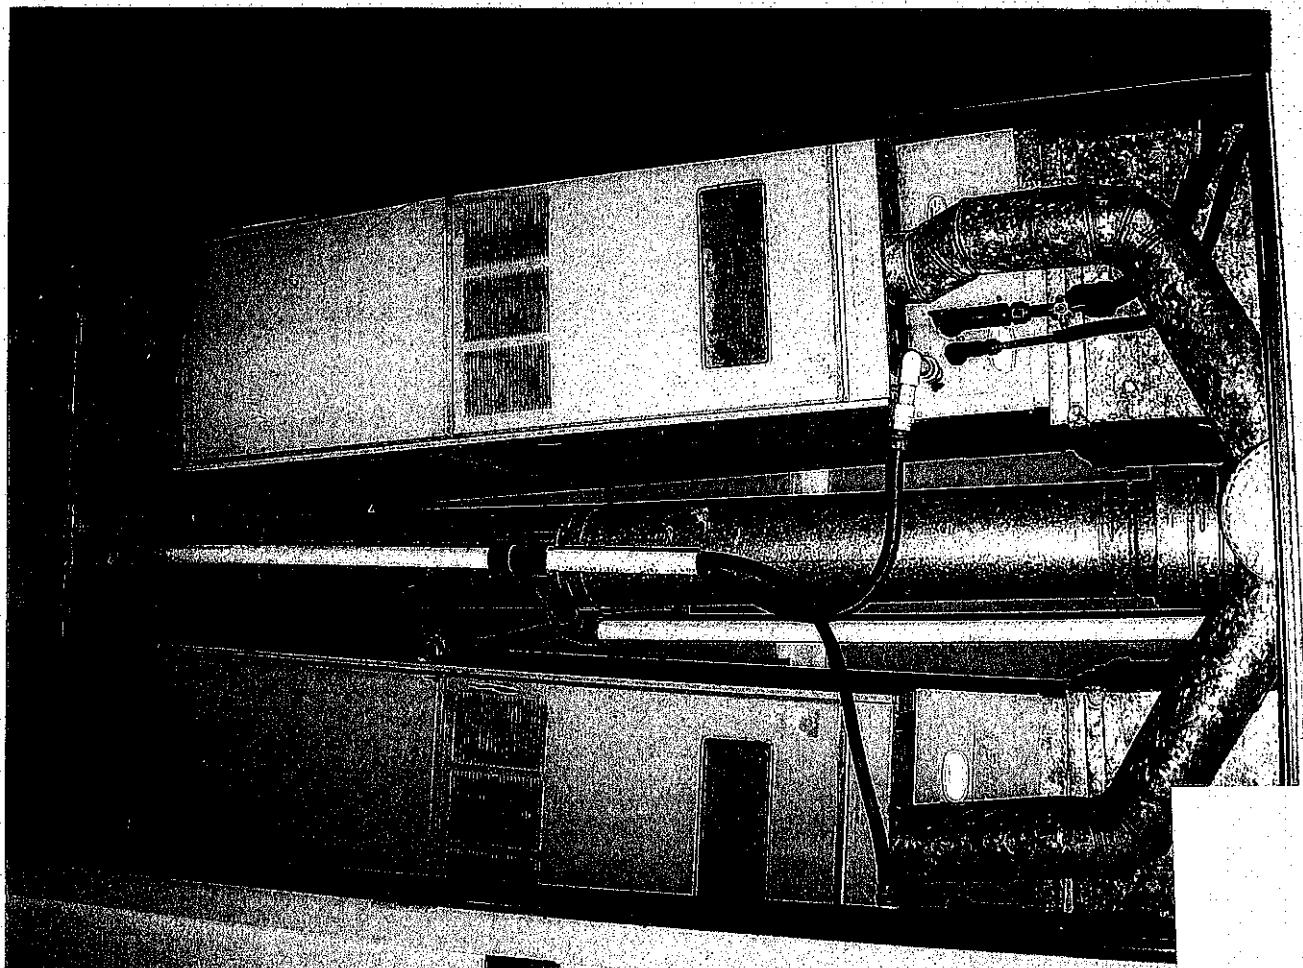
Finsnes leaning
Away from each other.

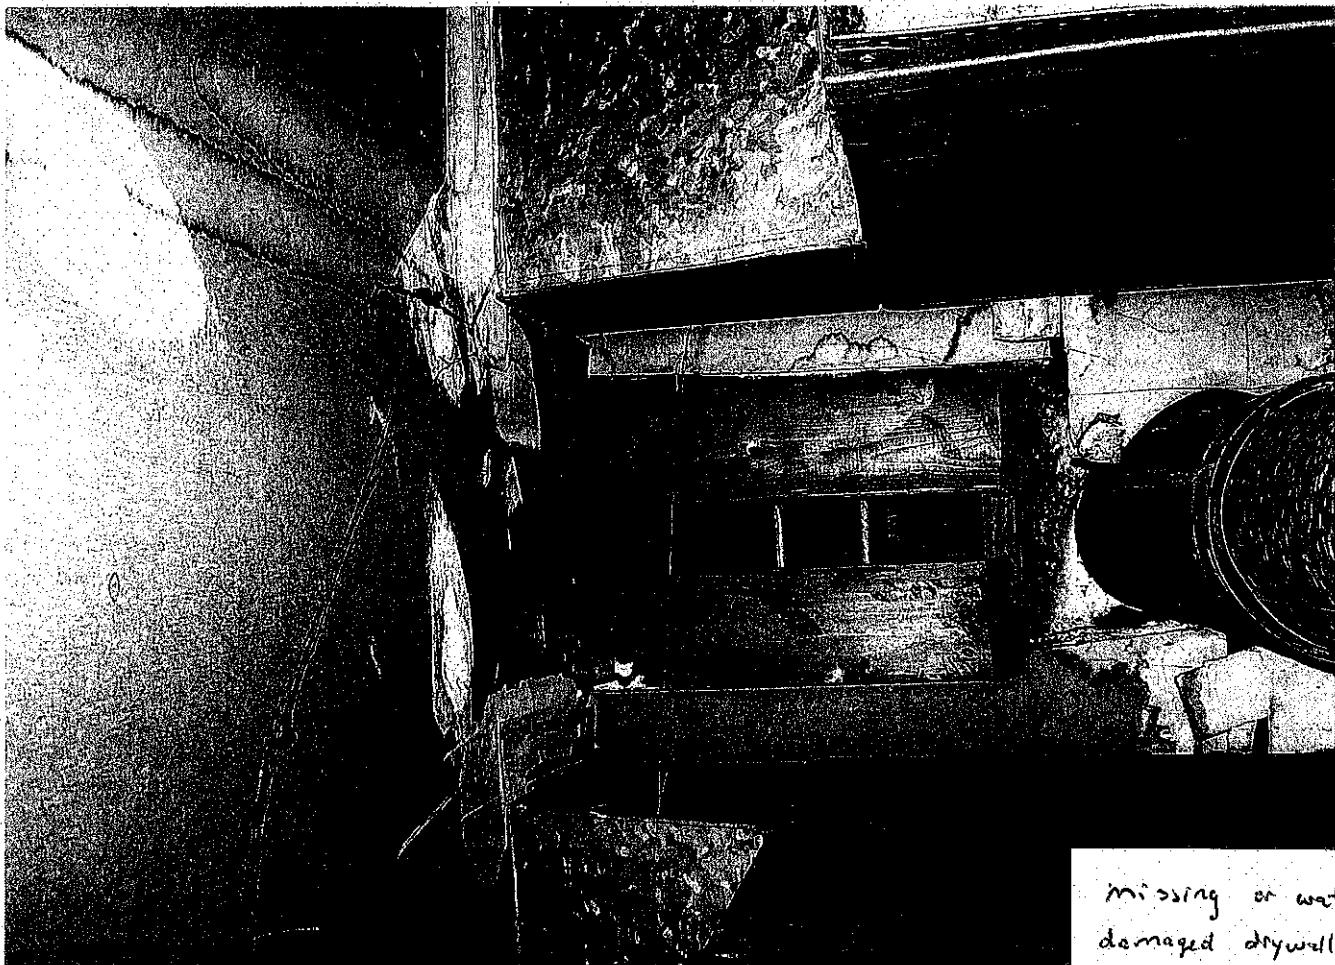
Missing or water
damaged drywall in
Ceiling of Mechanical
Closets. Should be a
Fire rated room.

The fire ratings of the mechanical rooms are compromised due to loose and damaged drywall at ceilings and walls, untapped drywall joints and unsealed wall penetrations. Repairing or replacing the damaged drywall and sealing the firewall penetrations with fire caulking are needed.

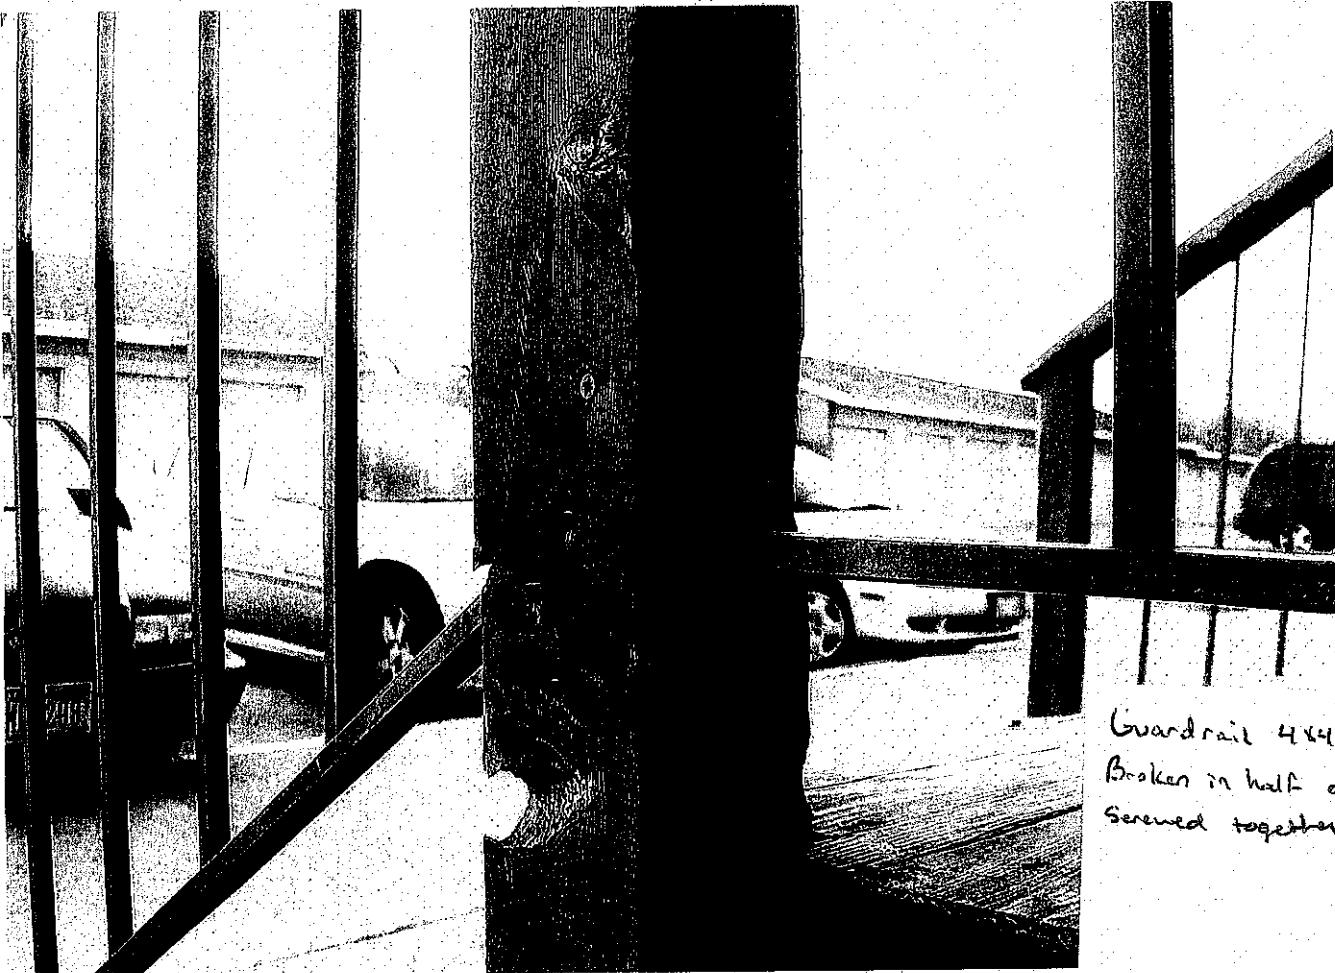
Guard rail 4x4 post
Broken in half and
Screwed together

The entry area decks to the three buildings that were inspected 8502, 8504, and 8506 all need the rim joists bolted to the structure, all have some level of rotted floor joists, loose, split, or displaced flooring boards that need repair. Several split or damaged stringers with loose treads were also noted. Loose guardrails and handrails noted. Please make the necessary repairs to ensure safety and code compliance.

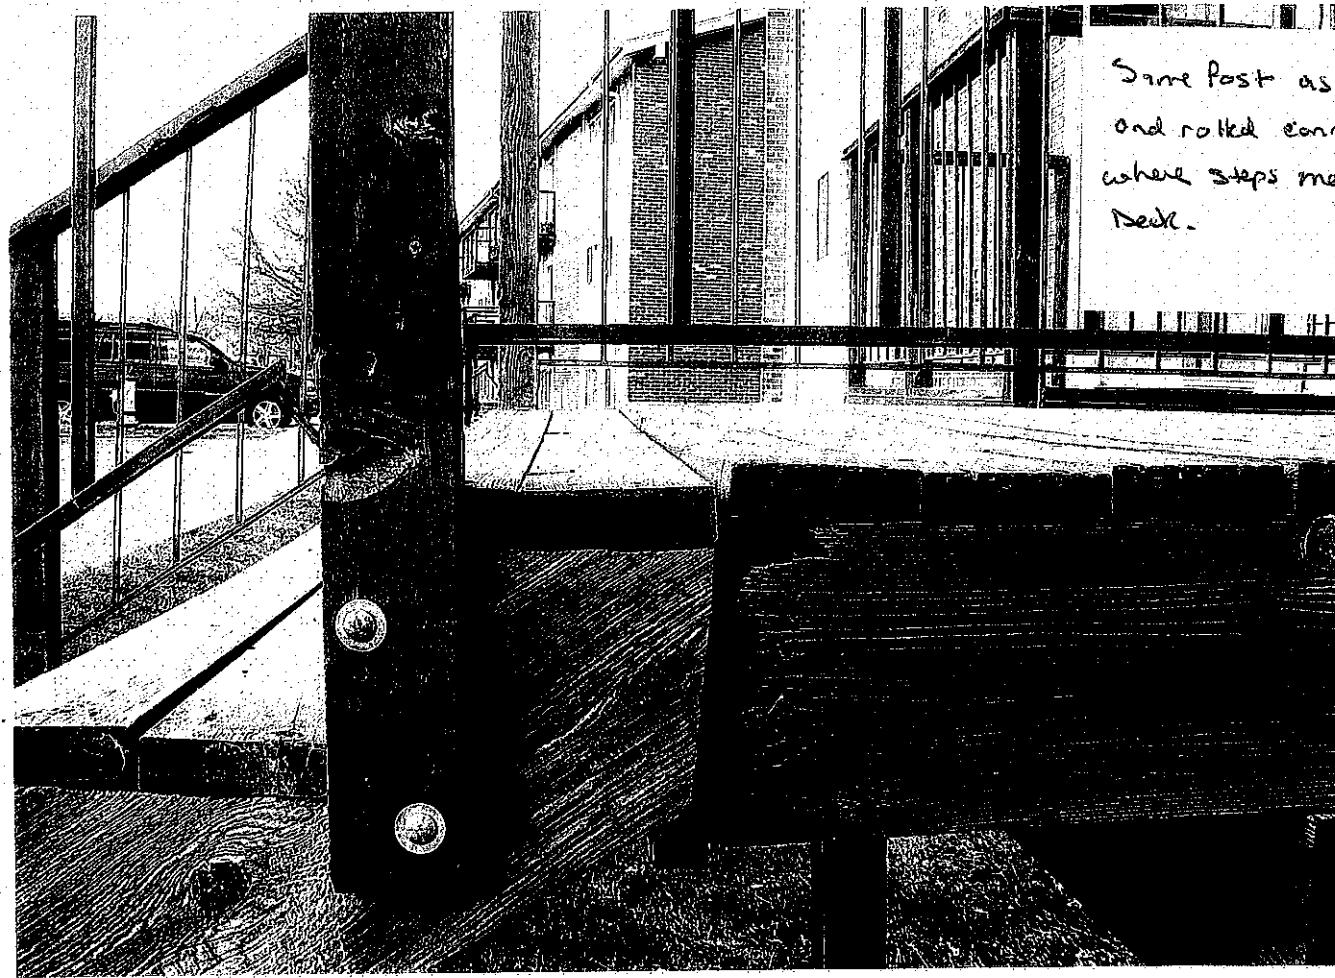
Same post as above
and rotted connection
where steps meet
deck.
