### **84<sup>th</sup> STREET BLIGHT AND SUBSTANDARD STUDY**

# Blight/Substandard Determination Study "84<sup>TH</sup> Street Redevelopment Area"

La Vista, Nebraska

NOVEMBER 2011

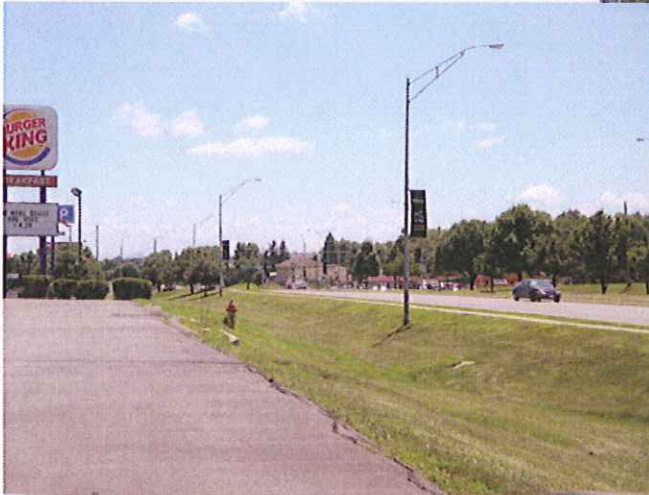
*No pedestrian sidewalks between businesses  
and 84<sup>th</sup> Street public sidewalk.*

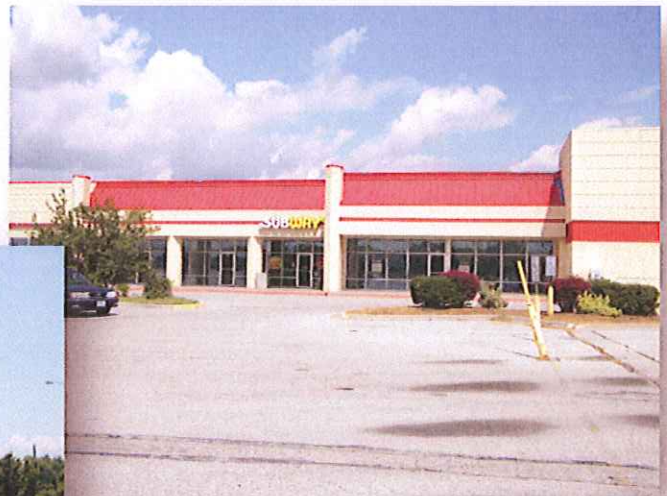
*Occupied storefront.*

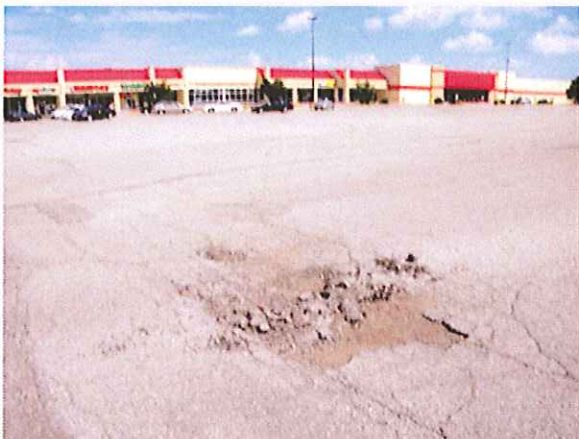
*Brentwood Plaza*

3. Parking lots throughout the **Redevelopment Area** lack designated pedestrian paths or sidewalks. If the parking lots would be fully occupied, pedestrians would need to walk up to a distance of approximately 300 to 400 feet from the rear of the lot to the front door of many retail establishments, through a deteriorated asphalt surfaced parking lot.

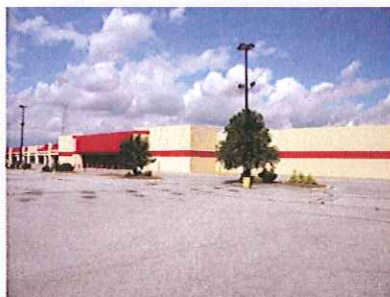
Former Walmart

**Other Environmental, Blighted Factors** are a strong presence throughout the **84<sup>th</sup> Street Redevelopment Area**, containing a significant amount of functionally and economically obsolete commercial properties and a variety of undevelopable narrow width lots.

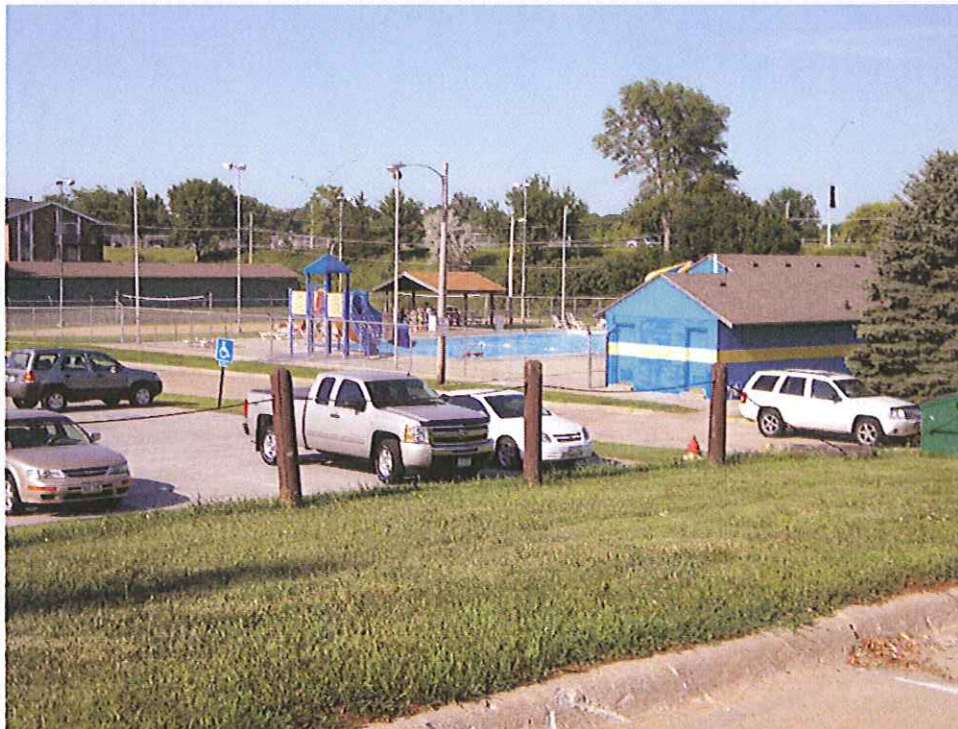
*The Municipal Pool and Kelly McMahon Park are located approximately 20 feet below the elevation of the 84<sup>th</sup> Street public sidewalk and the adjacent Shadow Ridge Apartments.*
