**CITY OF LA VISTA
MUNICIPAL FACILITIES PLAN**

FINAL REPORT

October 2008

LEO A DALY

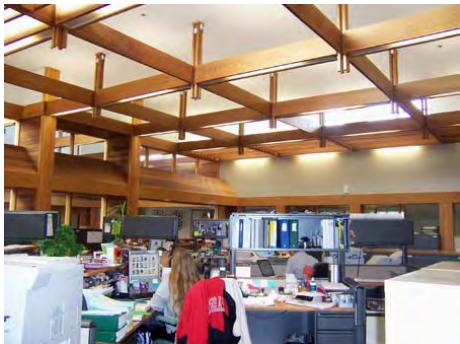
City hall front office is overcrowded and noisy.

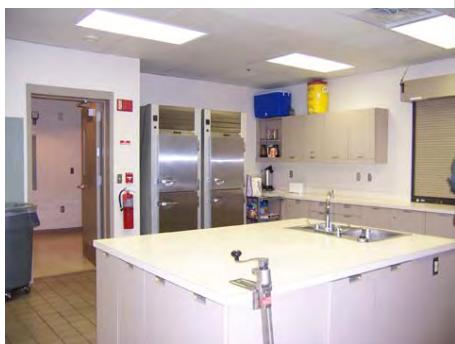
Senior Group would be better served if provided a dedicated space instead of sharing the Recreation Center kitchen and meeting rooms.

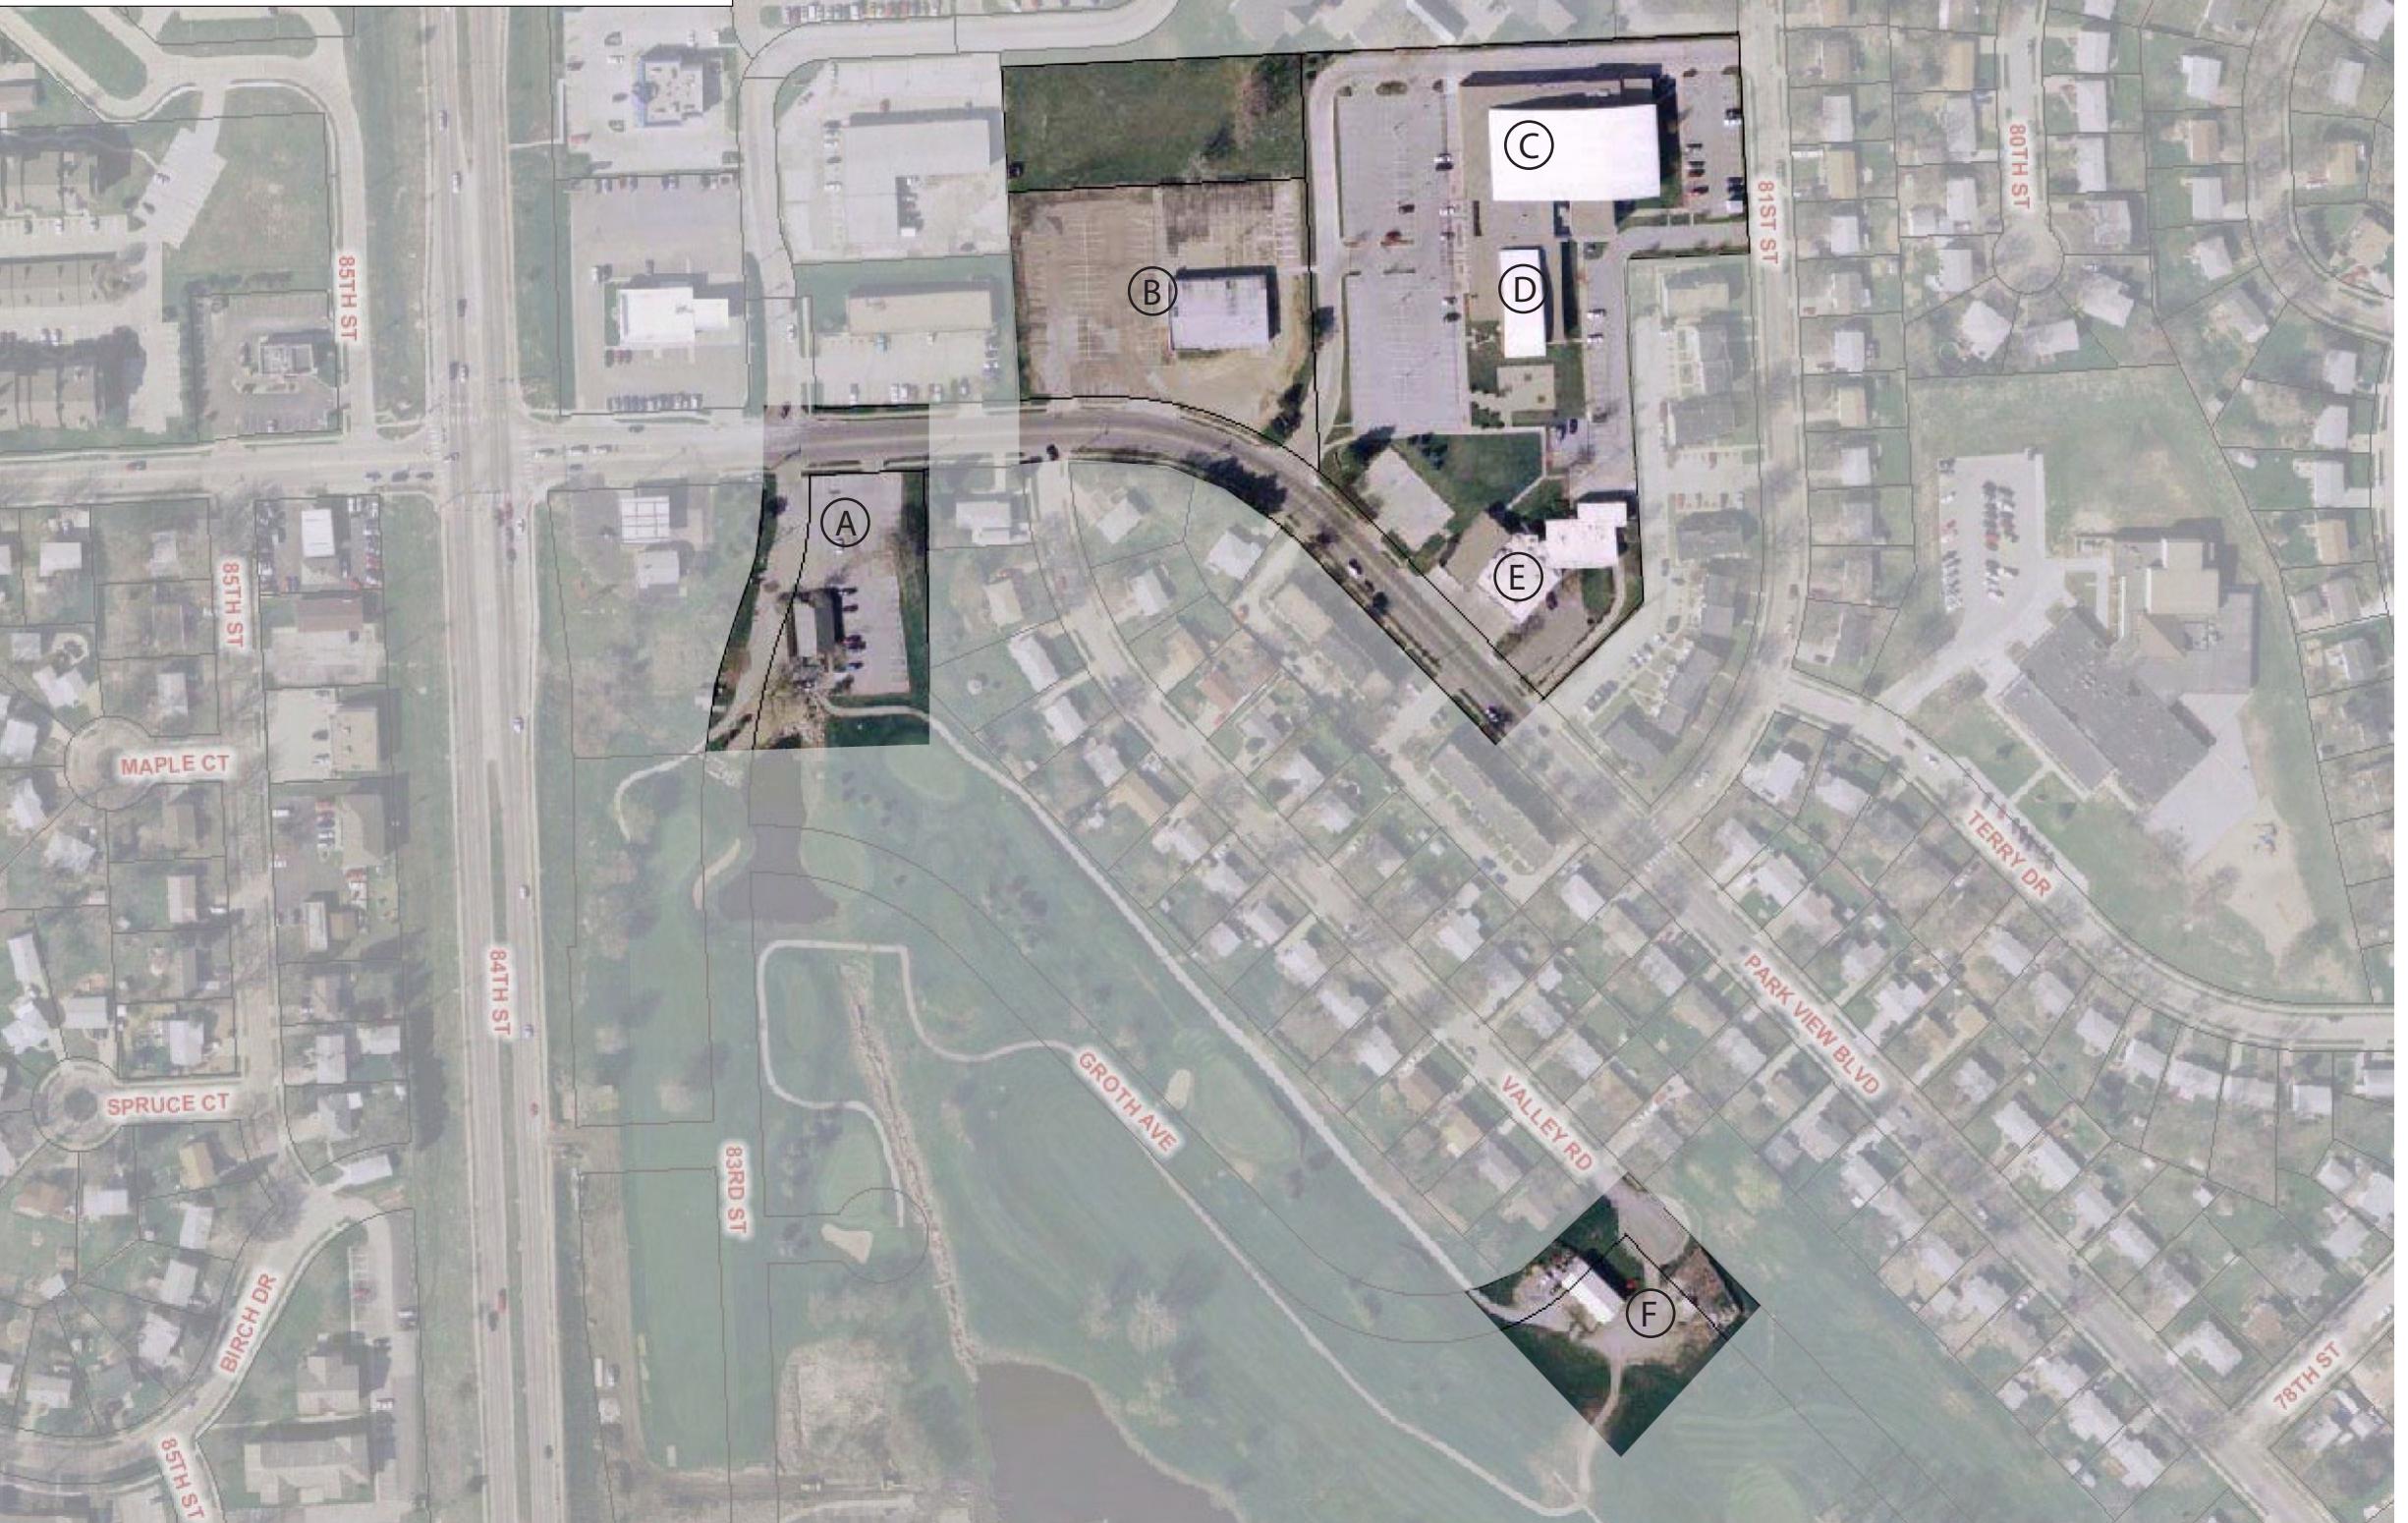
La Vista Municipal Facilities Plan La Vista, NE
City of La Vista FIGURE 2.1 - City Hall/Recreation Center, Fire Station #1 & Golf Facilities

- A. Golf Clubhouse
- B. City Owned Property
(Building and parking
lot has been removed)
- C. Recreation Center
- D. City Hall
- E. Fire Station #1 (with
Former Police Station)
- F. Golf Maintenance
Facility

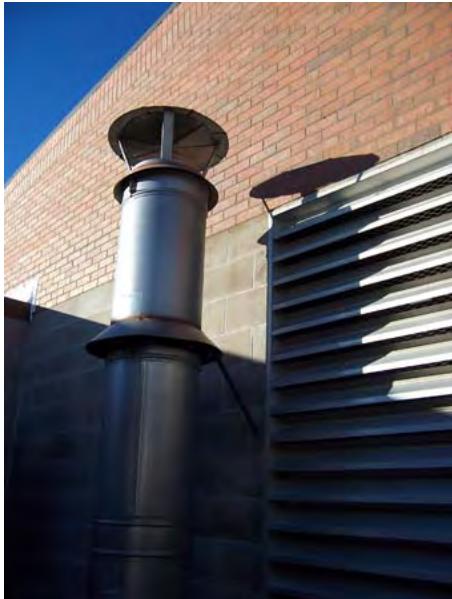
Boiler flue for the City Hall/Recreation Center should be extended so that it terminates two feet above the roof line.

- **Boiler Flue:** The boiler flue terminates adjacent to the building and below the roof line as shown on the photograph. NFPA 54 requires that flues from gas fired appliances terminate two feet above anything within 10 feet. Therefore, the flue needs to be raised to two feet above the roof or routed away from the building wall 10 feet.

Priority 1: Code Deficiency/Life Safety Projects			
Project Description	Building	Category	Cost Estimate
* Boiler flue termination extention	City Hall/ Recreation Center	Code Deficiency/Life Safety	\$1,000 - 1,500

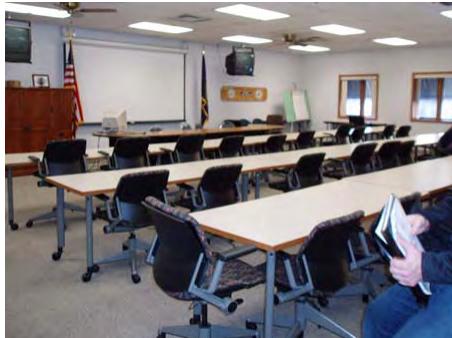
Training room and training officers are located in a different level of the building and disconnected from the rest of the station.

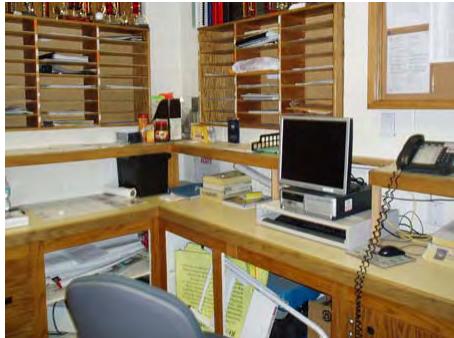
- Need more computer stations for staff to write reports with some privacy (HIPPA violations)
- Exhaust system for bays inadequate/inefficient – poor indoor air quality in building, exhaust is pushed into building (Non-compliance with NFPA codes)

Office space lacks privacy and has poor air quality due to the inefficiency of exhaust system in adjacent apparatus room.

- **Apparatus Room Ventilation:** Ventilation of the Apparatus room is currently adjacent to supply fans and relief hoods. The supply fans are over pressurizing the space sending diesel fumes into the building when the fire trucks start up. This system is in violation of NFPA codes. A new system could be installed that would exhaust 6 air changes/hour from the space. These exhaust fans would be located on the roof. To prevent freezing, an indirect gas fired make-up air unit would also be located on the roof. The make-up air unit would be sized to deliver slightly less than the exhaust air flow to maintain a negative pressure in the space.

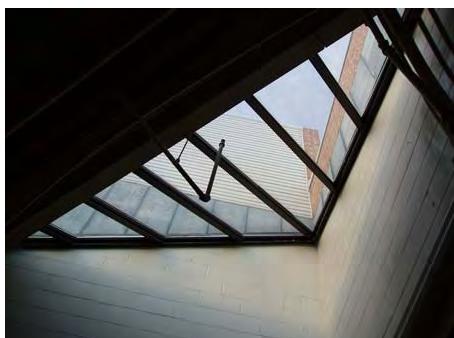
- Skylights in apparatus bay leak
- Underutilized space in old police office
- No Emergency Operations Center
- Tool room too small
- Not ideal for hosting firehouse tours, open house events, public education or fund-raising events

Skylights in apparatus room are prone to leaks.

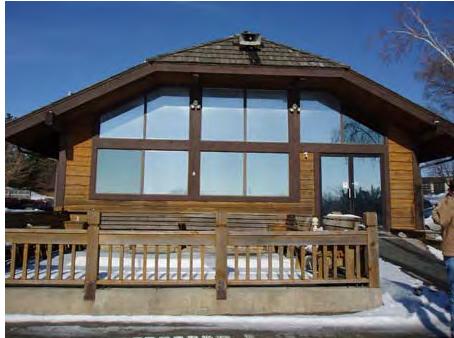
Large south facing windows on clubhouse are contributing to the heat gain problem making it difficult to maintain a comfortable temperature during the summer.

- Recommend extension of roof overhang on south side of club house to shade windows from summer sun and reduce heat gain/cooling load.
- Clubhouse meets minimum needs of the golf course
- Additional golf carts needed due to increase demand (25% increase last year) – no additional storage capacity.
- Kitchen facilities limit food service possibilities
- Small merchandising area/pro shop
- No locker rooms for golfers
- Restrooms small and out of date/appears dingy

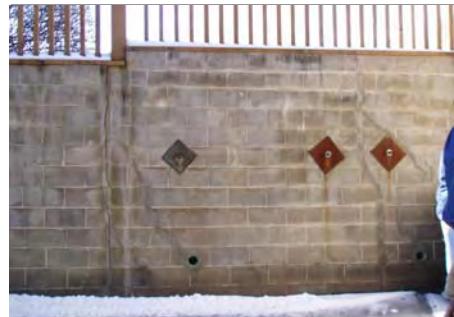
Retaining wall at golf clubhouse is not structurally sound.

- **Retaining Wall:** Retaining wall at golf cart ramp is not structurally sound and needs to be replaced.
- **Ramp Drainage:** Drainage in ramped area needs to be re-directed from sanitary sewer to storm sewer or day light to nearby pond.
- **ADA:** ADA accessibility at the Golf Club House Entrance needs to be provided.

* Entrance/Exits: ADA ramp repairs, Fire exit rail/curb fix	City Hall/ Recreation Center	Code Deficiency/Life Safety	\$15,000 - 20,000
Clubhouse golf cart ramp repairs: correct water pooling at bottom of ramp and structural retaining wall.	Golf Course Clubhouse	Code Deficiency/Life Safety	\$60,000 - 75,000
Alternative Clubhouse golf cart ramp repair: Correct water pooling at bottom of ramp and build "bracing deck" over northern 2/3 of ramp. Identify "No Parking" zone.			\$25,000 - 40,000
Site Improvements: New concrete apron with equipment wash water collection	Golf Course Maintenance	Code Deficiency/Life Safety	\$3,000 - 6,000

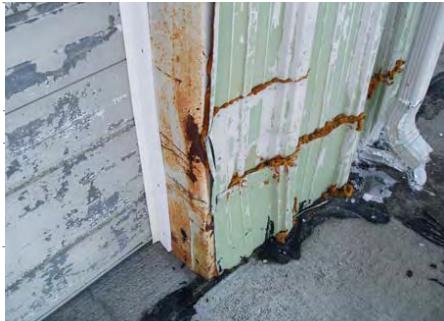
The sewer equipment has minimal clearance which results in occasional damage to the building and vehicle. This risk would be minimized by designing a new facility to accommodate the large scale of sewer equipment.

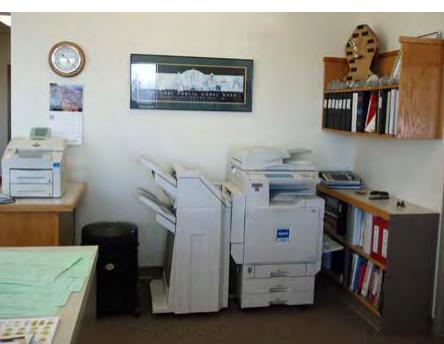
Copy and fax machines would be better located in a work room instead of the Public Works front office.

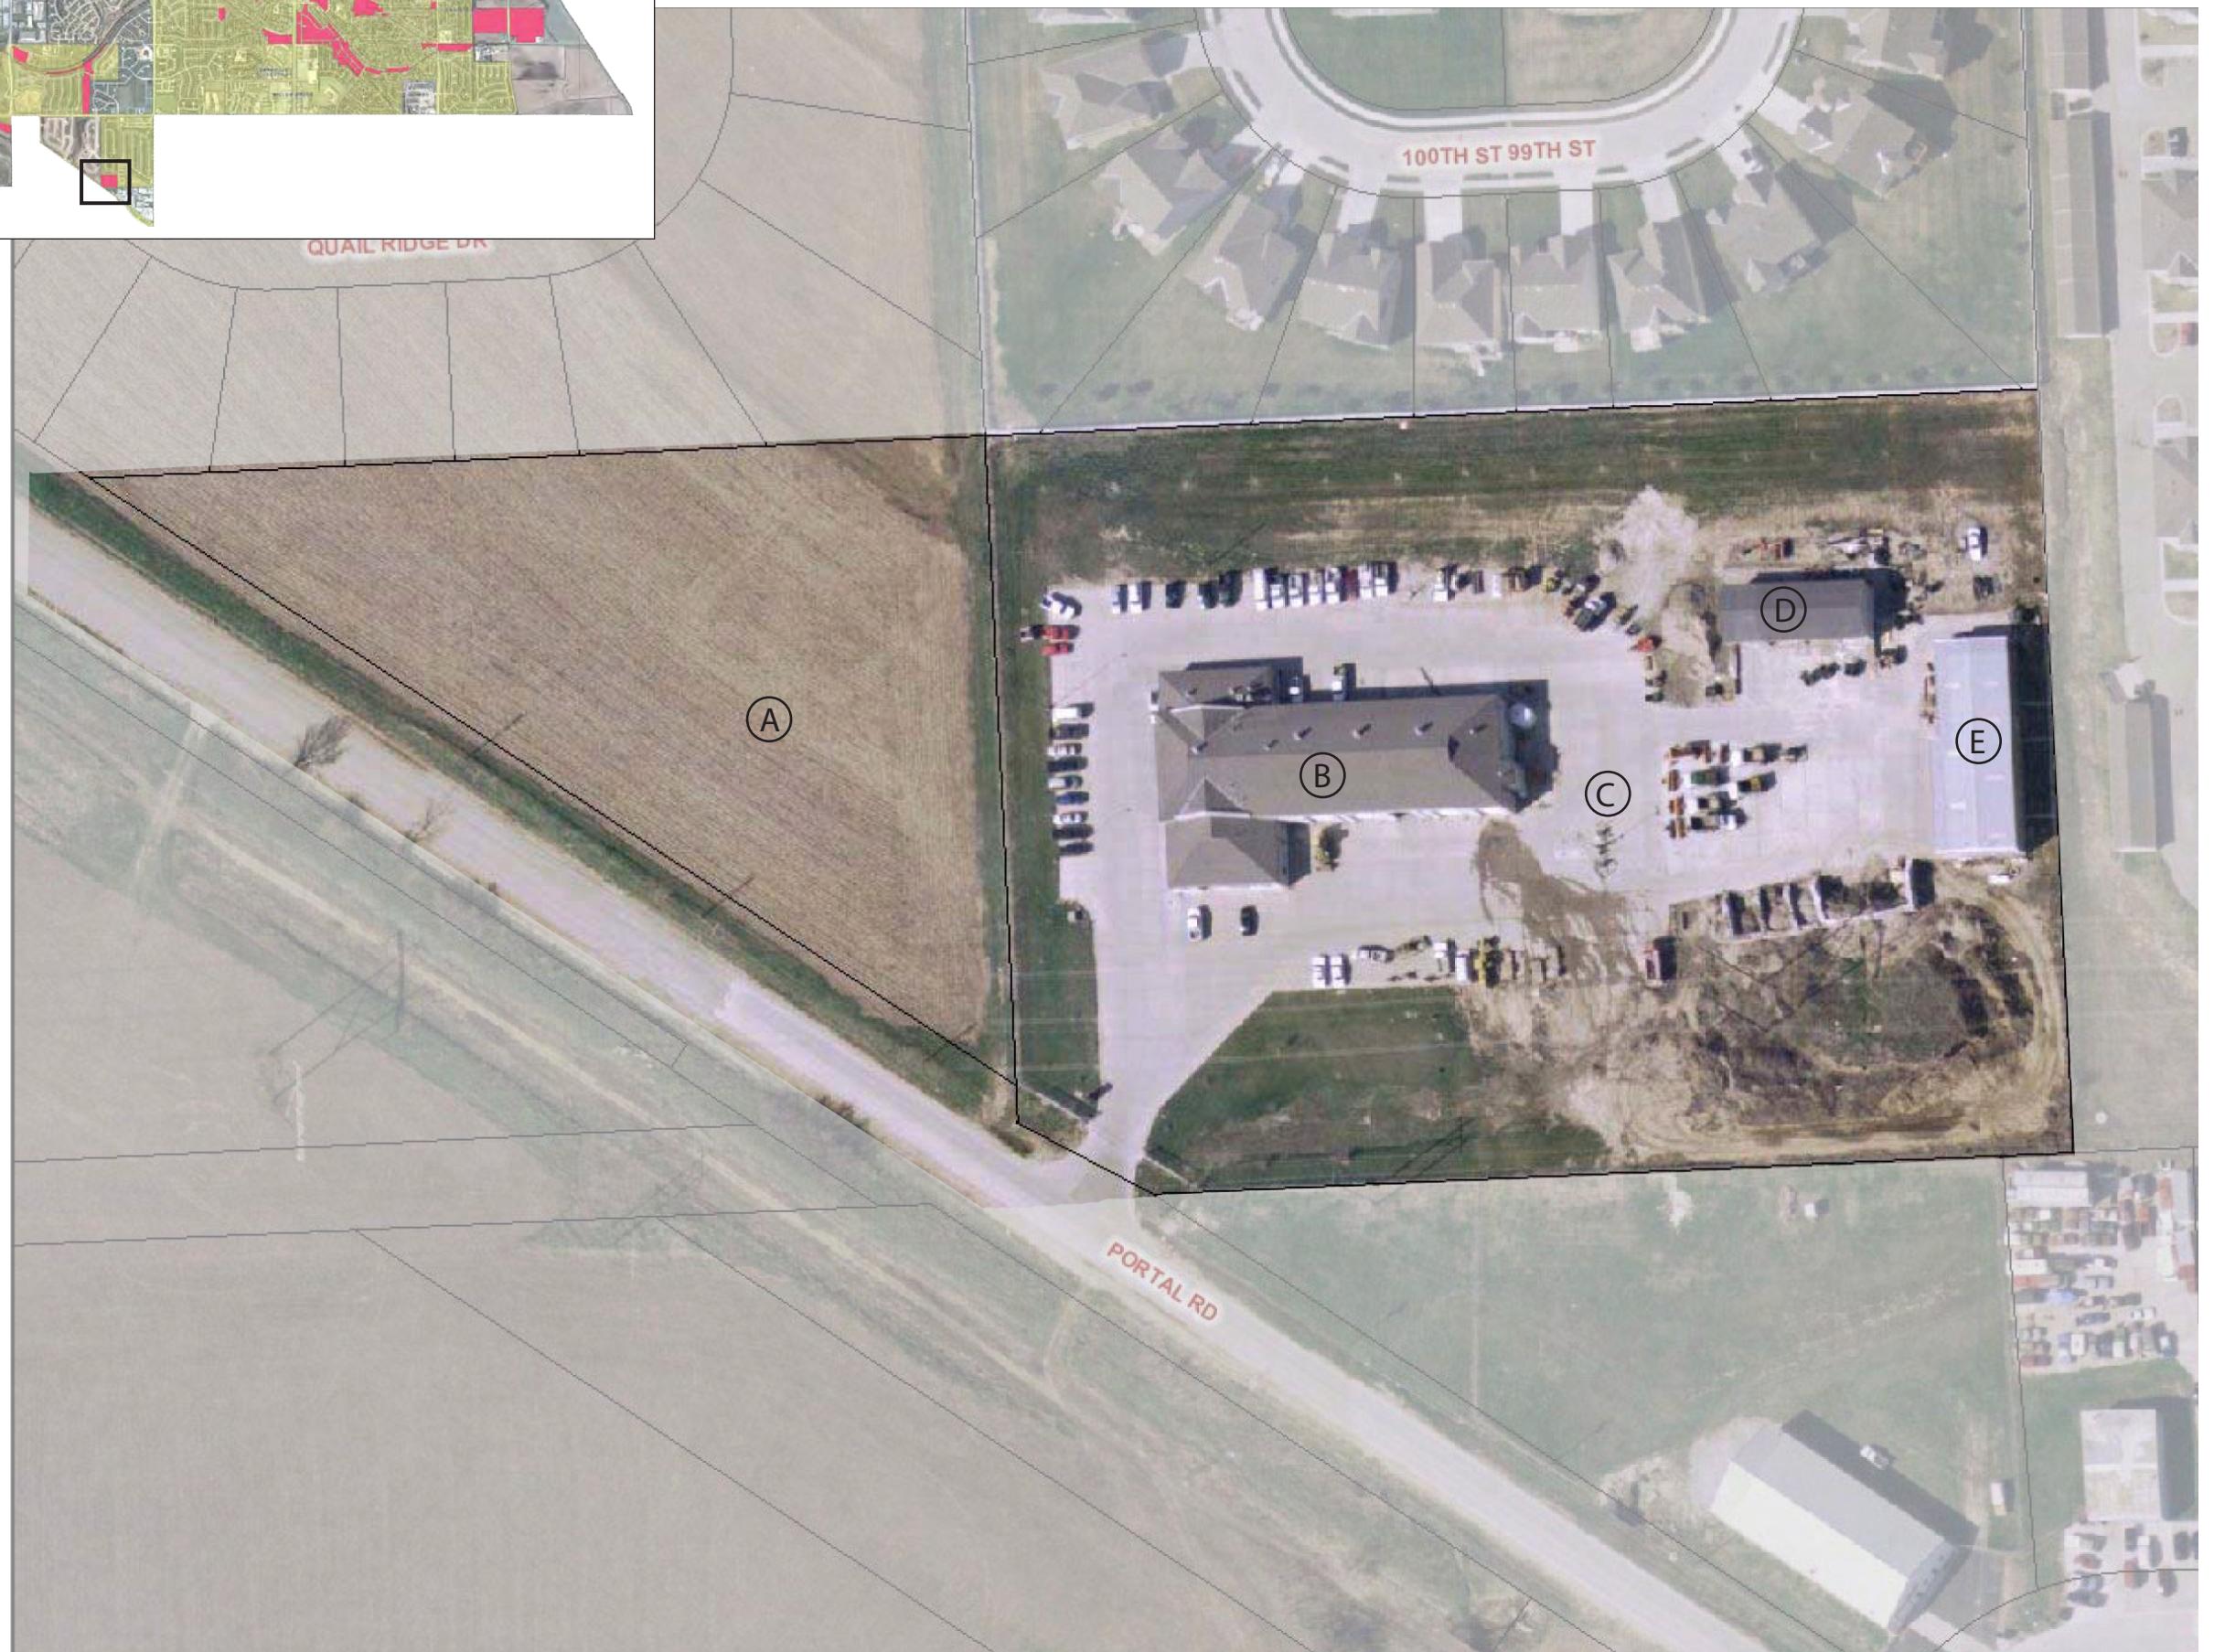
FIGURE 2.2 - Public Works Facility

- A. Possible Expansion Property
- B. Public Works Building
- C. Fueling Station
- D. Salt and Sand Storage
- E. Sewer Division and Cold Storage Building

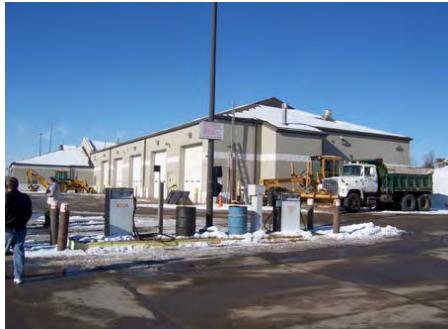
Fueling station and storage should have spill protection dike.

- **Spill Protection:** Fueling facility at the Public Works building should have a dike to prevent discharge from the area in case of a spill.
- **Stormwater Discharge:** The storm water coming from the area where the salt, sand, and the equipment are stored and repaired should be cleaned before leaving the site. The land along the south side of the site could be regraded to create an infiltration cell to capture the water and filter out impurities prior to leaving the site.
- **Screening:** Add a massing of trees to screen and enhance the facilities from the adjacent neighbors.

* Fueling Station: Install/construct fueling station spill dike	Public Works	Code Deficiency/Life Safety	\$30,000 - 40,000
* Storm water: Collect run off for salt/sand storage area	Public Works	Code Deficiency/Life Safety	\$50,000 - 70,000

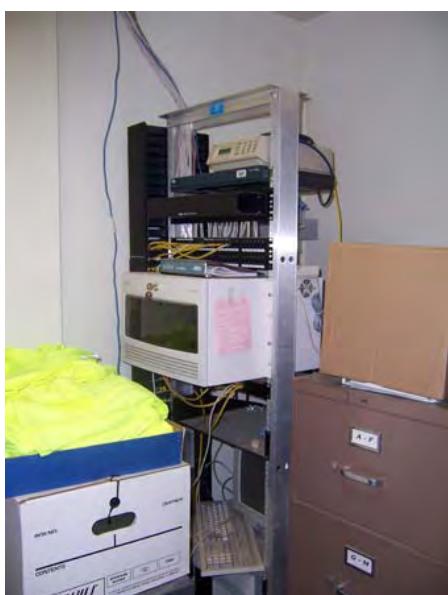
Server room is also used for storage, due to security issues access to the server should be restricted.
