### **84<sup>th</sup> STREET BLIGHT AND SUBSTANDARD STUDY**

# Blight/Substandard Determination Study "84<sup>TH</sup> Street Redevelopment Area"

La Vista, Nebraska

NOVEMBER 2011

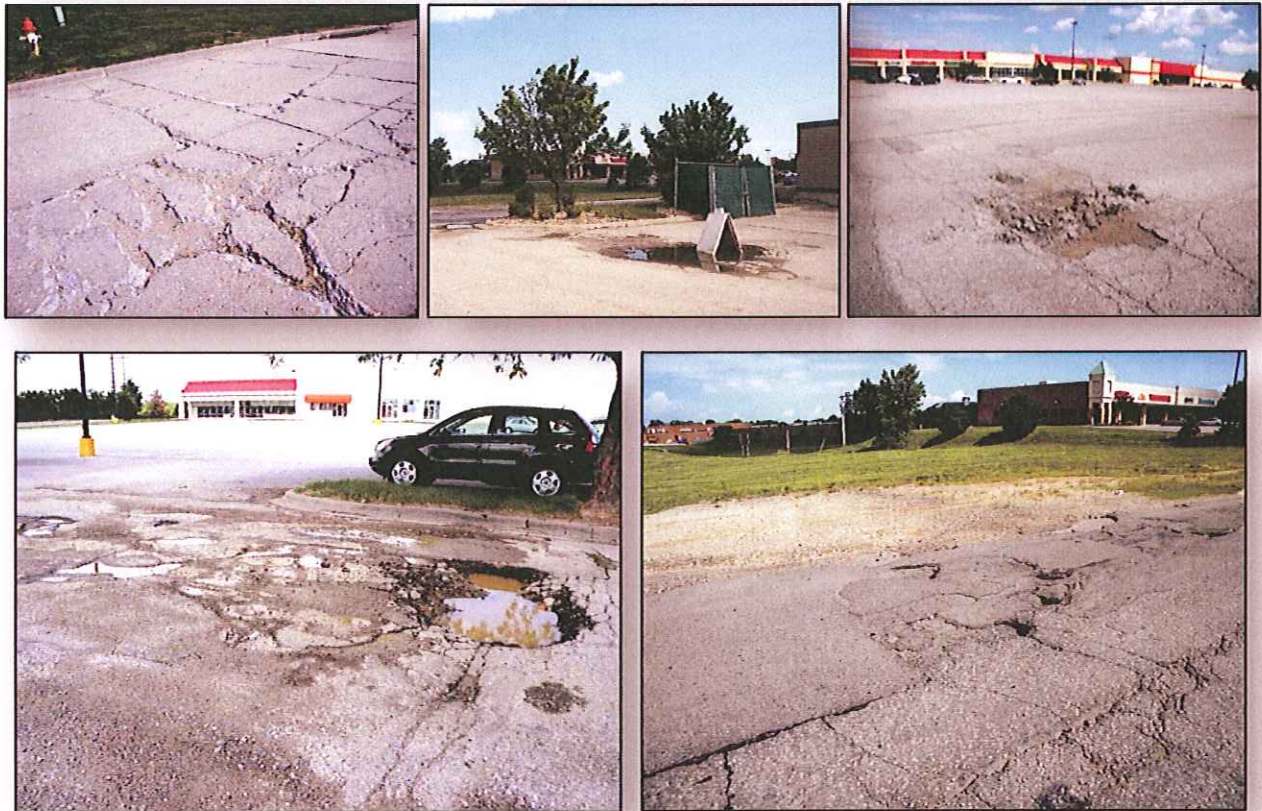
***Defective or Inadequate Street Layout*** is a **strong presence** in the 84<sup>th</sup> Street Redevelopment Area due to a significant percentage of privately owned and maintained “frontage” streets that are significantly deteriorated. Large areas are impacted by “alligator cracking” and settling, as well as several potholes within street rights-of-way and in private parking lots. Many of these potholes are large enough to damage motor vehicles. Additional frontage street sections lack concrete curbs, gutters and storm water drainage systems.

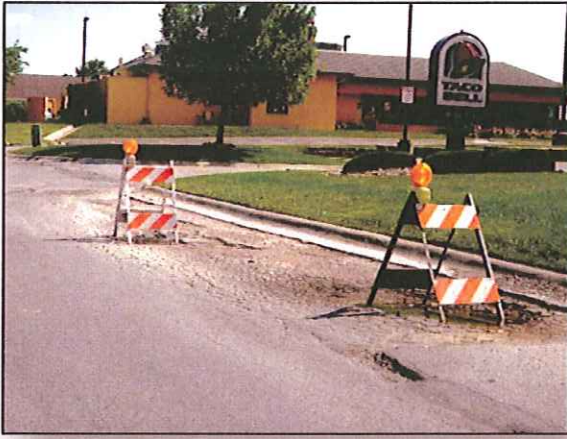
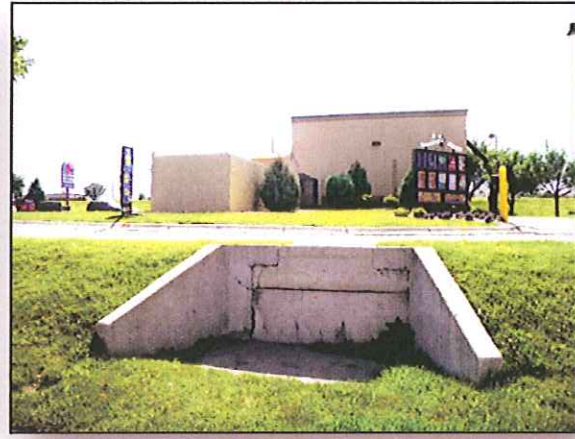
***Insanitary or Unsafe Conditions*** are a **strong presence** throughout the entire the 84<sup>th</sup> Street Redevelopment Area. Conditions contributing to this **Factor** include poorly designed and implemented, privately owned, storm water surface drainage systems and the advanced age of privately owned and maintained underground water, sewer and storm sewer mains in the **Redevelopment Area**.

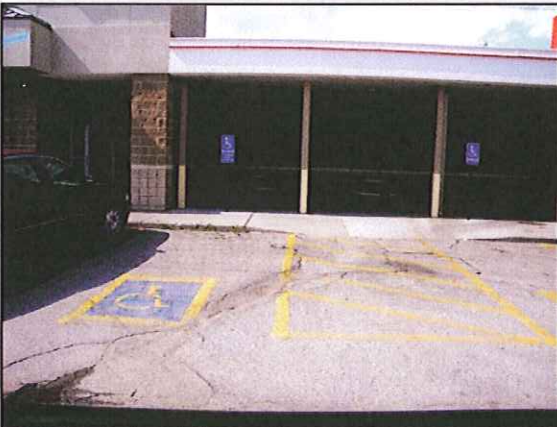
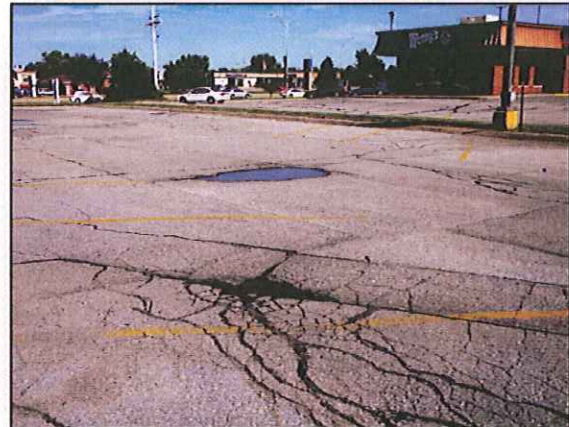
*Deterioration of Site or Other Improvements* is a **strong presence** throughout the Area, where, of the total 63 parcels examined, 44.4 percent, or 28 parcels have “fair” to “poor” overall site conditions.

The *Diversity of Ownership* is a **strong presence** throughout the 84<sup>th</sup> Street Redevelopment Area. Research of public records from the Sarpy County Assessor’s office indicates that 40 individuals own property in the **Redevelopment Area**.

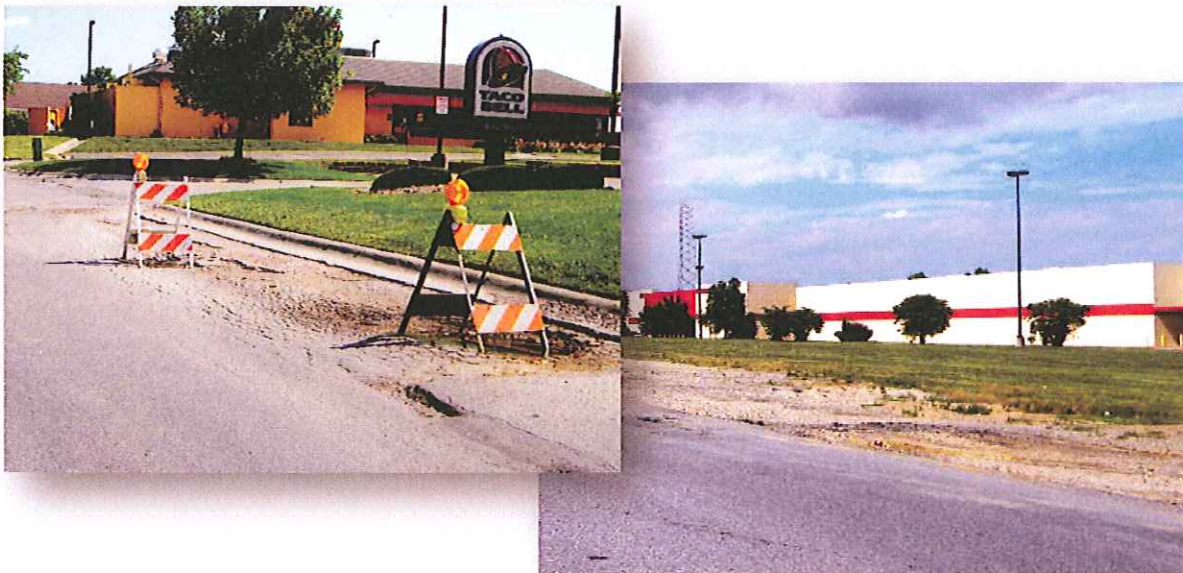
The existence of defective or inadequate street layout in the 84<sup>th</sup> Street Redevelopment Area is a strong presence and constitutes a Blight Factor.

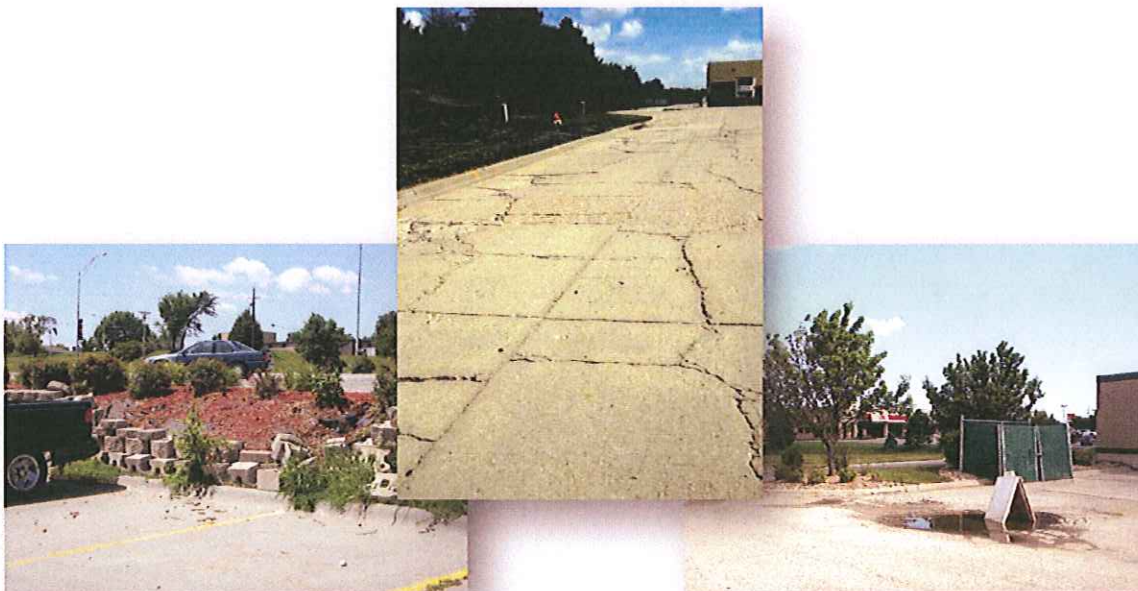
1. Many buildings and/or shopping facilities throughout the **Area** are accessed by asphalt or concrete surfaced streets. Several segments of privately owned “frontage streets” were observed to lack concrete curbs and gutters and thus have open storm water drainage ditches. These frontage roads were also observed to be severely deteriorated with large areas impacted by cracking and settling. Many of these street segments also have several potholes, some that are large enough to damage vehicles to the extent that they are barricaded to divert traffic. As a result, these roads can become impassable during inclement weather. Ponding water in the areas with settling, potholes and storm water drainage ditches can attract mosquitoes and other pests.
